# New Research Pinholes in

*A noted researcher reports that he has made a breakthrough in addressing an ongoing corrosion problem.*

# May Explain Copper Tubing

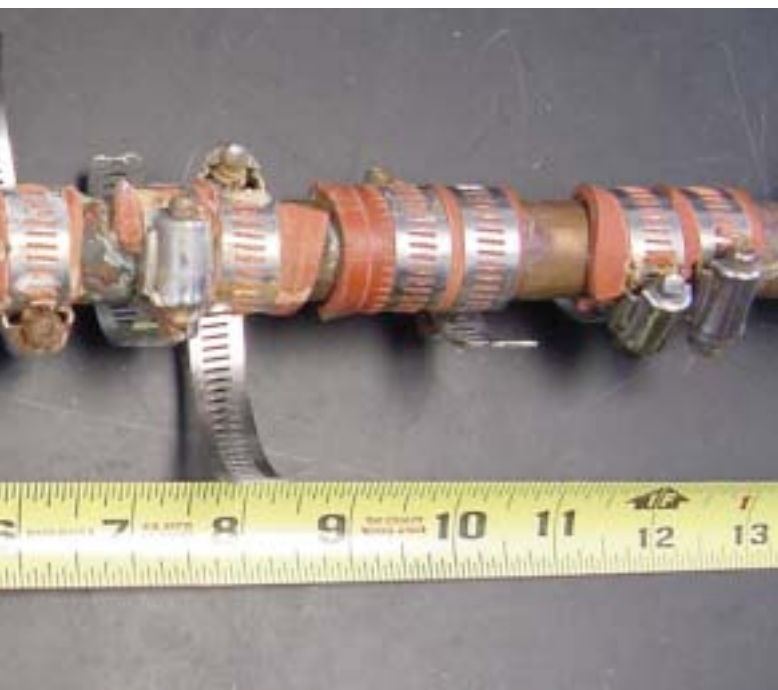
This copper pipe, from the D.C. WASA system, is largely hidden by clamps placed over individual pinhole leaks. There have been cases in which such leaks have occurred at a frequency greater than one per inch of copper tube, and hundreds of leaks have occurred in individual buildings. New research from Virginia Tech concludes that aggressive water, partly an effect of federal water quality regulations, causes this problem. Photo courtesy of Marc Edwards, Department of Civil and Environmental Engineering, Virginia Tech, Blacksburg, Virginia.

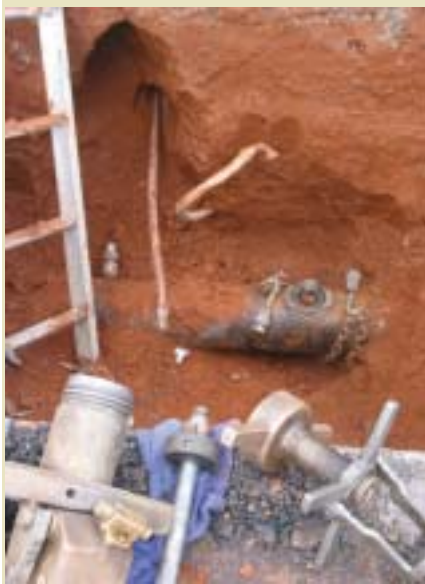
Aggressive water can attack metallic plumbing materials other than copper. Exceedances of the EPA's lead action limit can force utilities to replace existing lead pipe. This photo shows a pit dug to partly replace an existing publicly owned lead pipe with a copper pipe. Photo courtesy of Marc Edwards, Department of Civil and Environmental Engineering, Virginia Tech, Blacksburg, Virginia.
